State of Washington Department of Ecology
Northwest Regional Office
**STORMWATER COMPLIANCE INSPECTION
REPORT**

Name and Location of Facility Inspected Glacier NW 5975 E. Marginal Way S. Seattle, WA 98111	USEPA SF 1316335	Entry Time 0900	Permit Effective Date 2/14/2005
		Exit Time 1200	Permit Expiration Date 2/14/2010

UNANNOUNCED Inspection

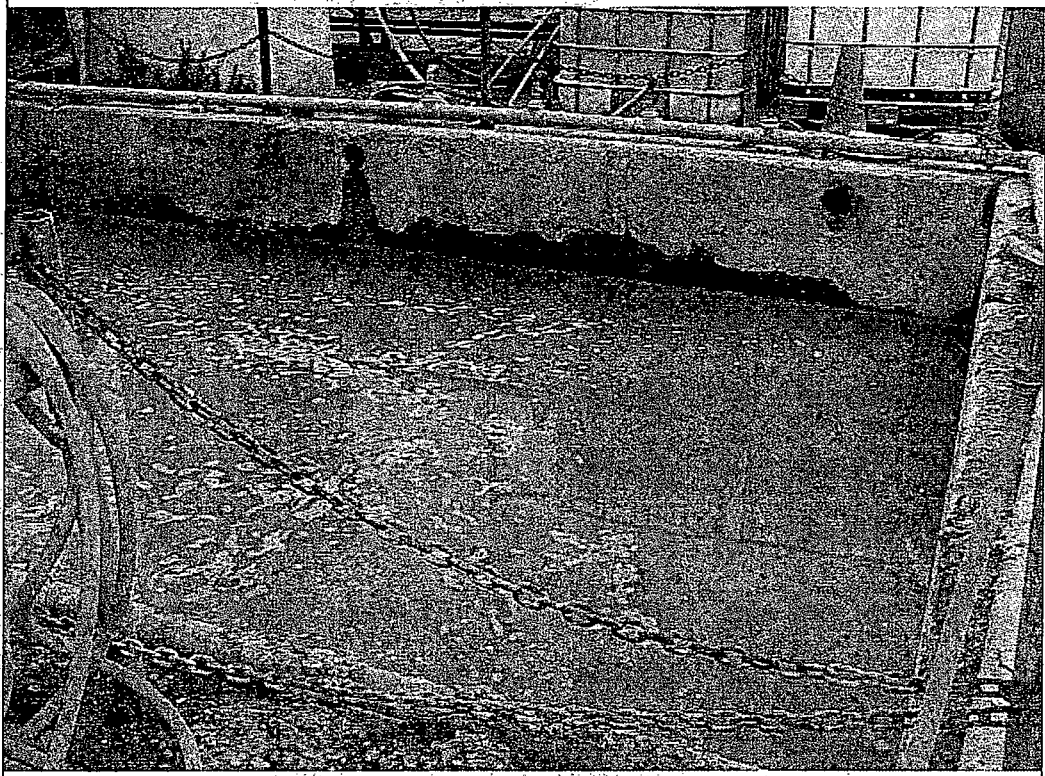
Photo #: 1

Description:
Truck wash out pond which also collects wash from the pad. This water goes through a series of ponds and is either re-used, discharged to the POTW, or treated and discharged to surface water in accordance with the permit.

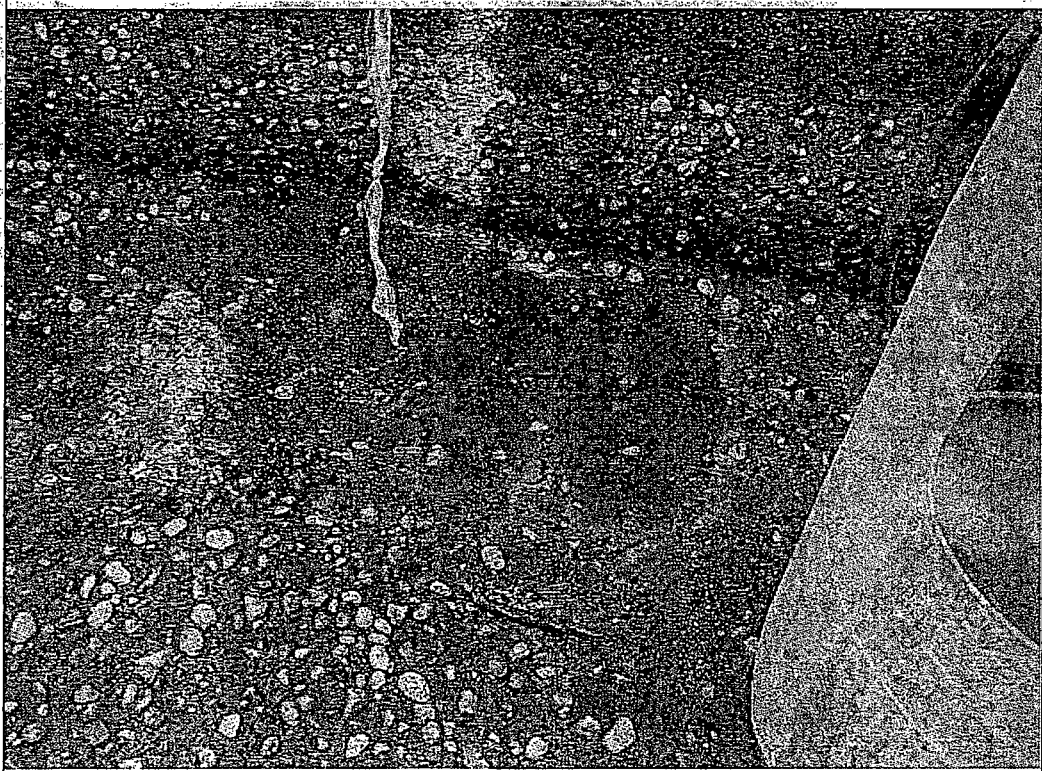
Photo #: 2

Description:
Although no discharge to ground at this time due to concrete slab, the integrity of the concrete must be maintained. This is area near the front of facility.

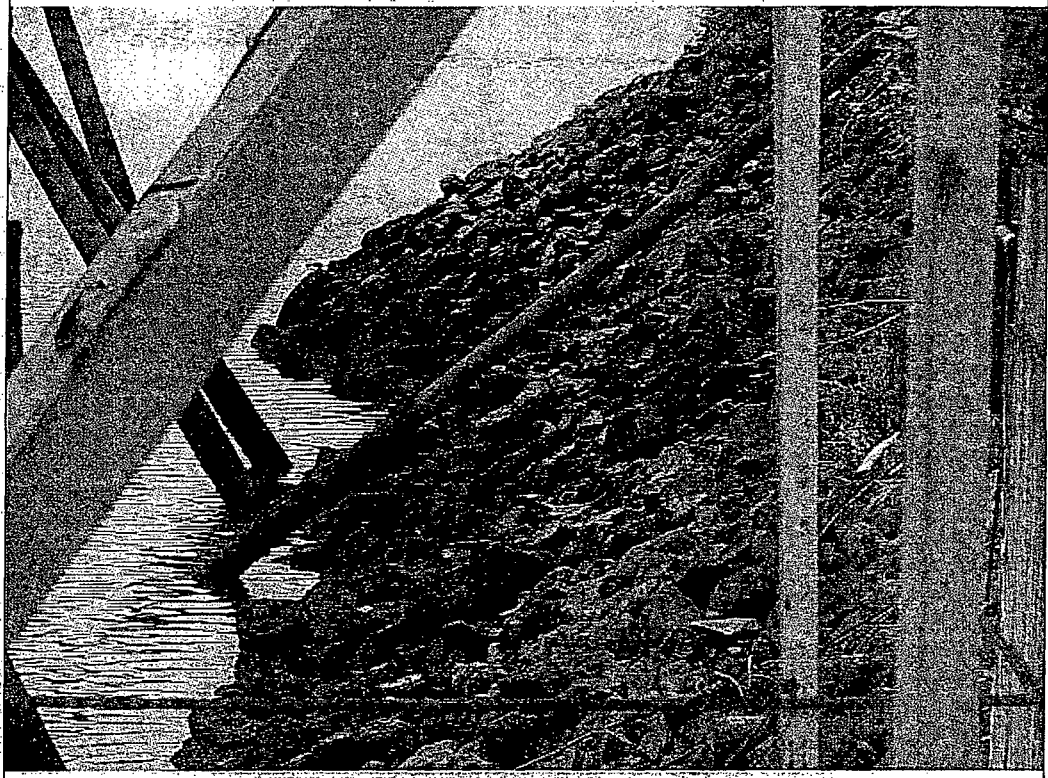
Photo # 5

Pictured here is the discharge pipe to surface water, the Duwamish.

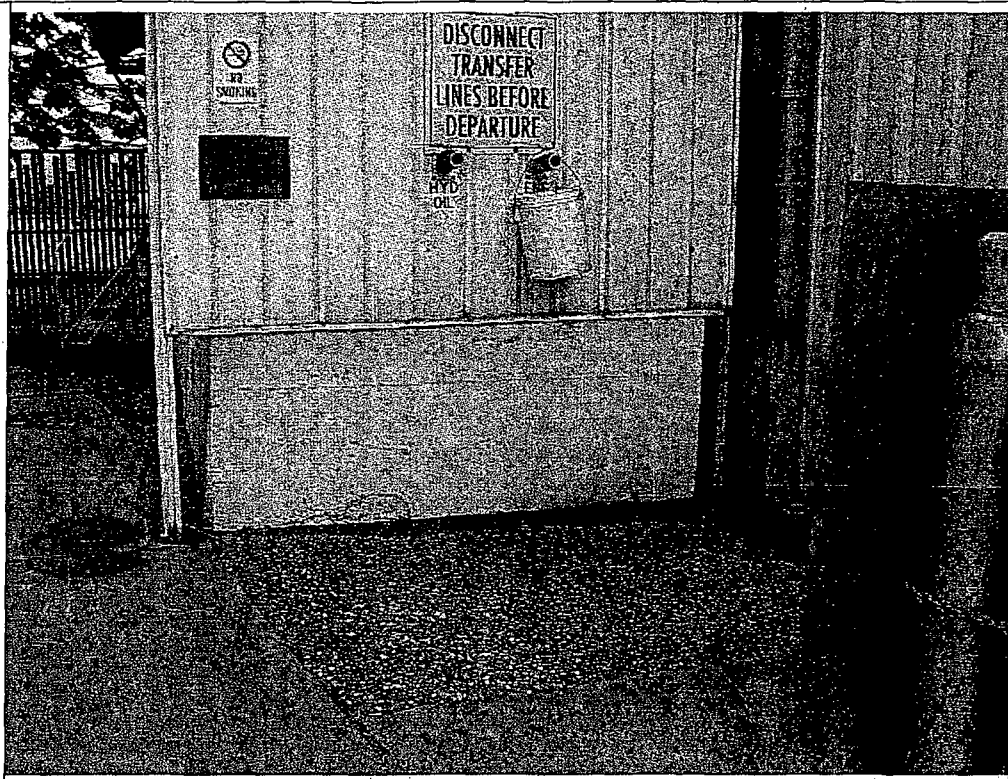
Photo #: 9

- Two tanks which hold waste oil and fluid situated adjacent to the shop area were observed having no containment under the outside spickets. (Photo # 9) A spill will discharge to ground so a recommendation was made for this area to be paved for containment. The permit (S11.) calls for the prevention and containment of oil and petroleum products.

A recommendation was made for this area to be paved so any spill could be contained and not discharge to ground. The permit calls for the prevention and containment of oil and petroleum products.
